ENVIRONMENTAL ASSESSMENT
Fisheries Division
Montana Fish, Wildlife & Parks
Haughian Bass Reservoir spillway repair

Project Title: Haughian Bass Reservoir spillway repair

Description of Project: The Program tentatively plans to provide partial funding toward the replacement of an ice-damaged spillway pipe, trash rack, and concrete pad at Haughian's Bass Reservoir, which is a 133 acre impoundment of Physic Creek north of Miles City in Custer County.

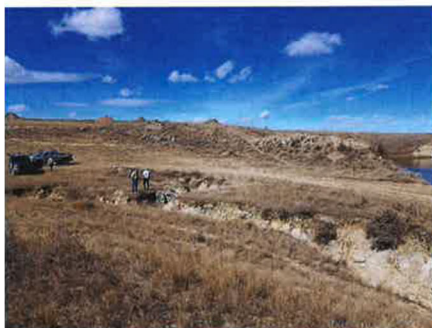
FIGURE 2: Existing conditions.

Top photo shows a head cut adjacent to dam (yellow circle), borrow area that is the source of runoff water (blue circle), and the potential dike location to reroute runoff (green arrow). Bottom photo shows a the headcut.

The project proposes to replace an ice-damaged spillway pipe, trash rack, and concrete pad at Haughian's Bass Reservoir, as well as fill a head cut and regrade the dam barrow area to improve water drainage. The overall goal is to improve the integrity of the dam and ensure proper storage and water depth for fish. This project is expected to cost \$4583.20. Of this total, the FFIP would be contributing up to \$4,100 to complete the project.

This project intends to repair a headcut and improve drainage. The impacts are considered to be positive long-term.

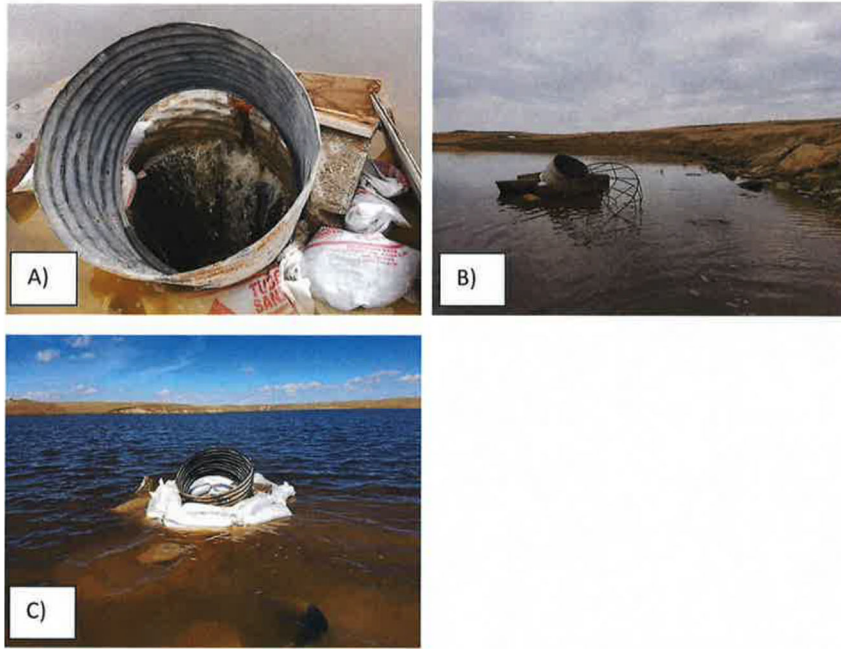
(A)
FIGURE 3: Existing spillway pipe.
(A) Closeup of damaged spillway pipe; (B) overall view looking northeast; (C) Short-term fix with sandbags to reduce water loss.

The FFIP tentatively plans to provide partial funding toward the replacement of an ice-damaged spillway pipe, trash rack, and concrete pad at Haughian's Bass Reservoir.

One goal within FWP's Statewide Fisheries Management Plan for the fisheries management program is to "restore and enhance degraded fisheries habitats." By implementing an improvement project and restoring important habitat, this proposed project would help meet this goal. A damaged spillway pipe, trash rack, and concrete pad at Haughian Bass Reservoir has threatened the spillway and water depth for a popular fishery in Region 7 (Figures 2 and 3). Making the improvements would restore storage capacity and reduce the risk of a fish kill during winter months. Ensuring proper water depth will enhance habitat for all fish species present.
